# **INDOOR AIR QUALITY ASSESSMENT**

**Oak Bluffs Town Hall  
56 School Street  
Oak Bluffs, Massachusetts**

Prepared by:  
Massachusetts Department of Public Health  
Bureau of Environmental Health  
Indoor Air Quality Program  
December 2018

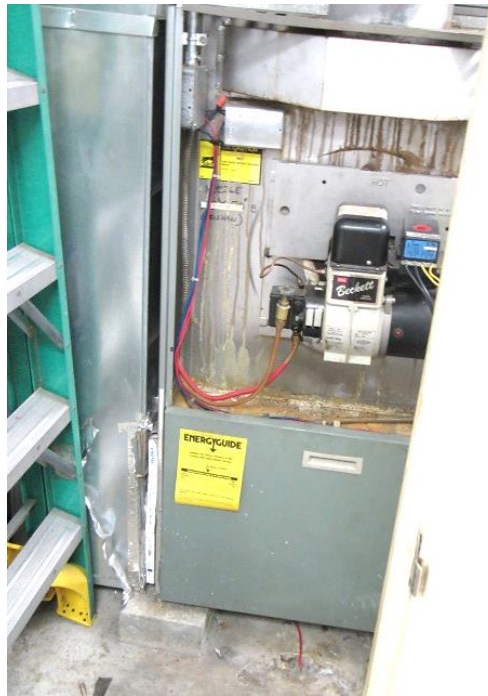
**Picture 1**

The heating, ventilation and air conditioning (HVAC) system consist of air handling units (AHUs) located in a mechanical room on the main level (Picture 1). Conditioned air is supplied via ceiling or wall-mounted diffusers (Picture 2) and ducted back to the AHUs via return vents (Picture 3). The AHUs appear to be several decades old. Efficient function of equipment of this age is difficult to maintain, since compatible replacement parts are often unavailable. According to the American Society of Heating, Refrigeration, and Air-Conditioning Engineering (ASHRAE), the service life<sup>1</sup> of this type of unit is 15-20 years, assuming routine maintenance of the equipment (ASHRAE, 1991). It appears the optimal operational lifespan of this equipment has been exceeded.

**Air handling unit (AHU) in mechanical closet**

5. Due to the age/condition of HVAC system/components, develop a plan for replacement or overhaul of the HVAC systems including the controls.
6. Consider adopting a balancing schedule of every 5 years for all mechanical ventilation systems, as recommended by ventilation industrial standards (SMACNA, 1994).

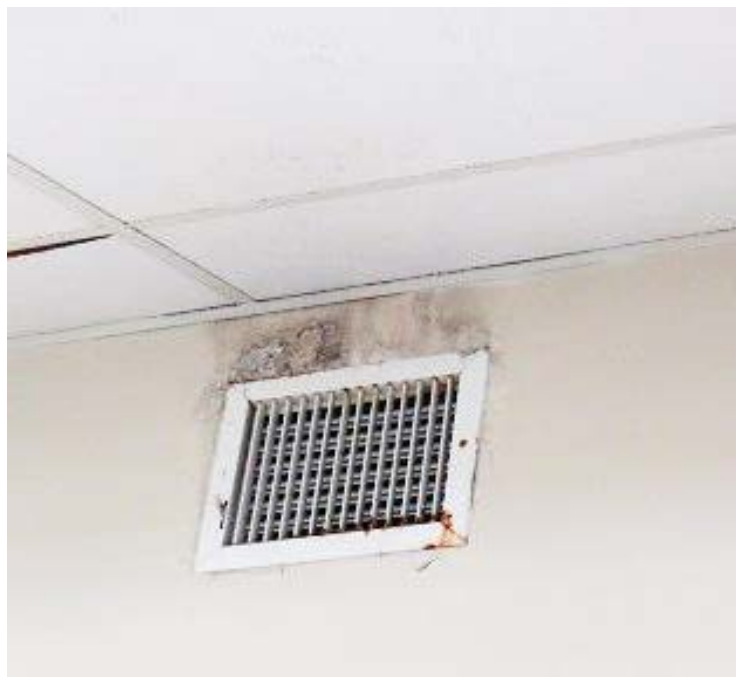
**Picture 2**

Visible mold growth was observed on drywall in the Building Department (Picture 2), which should be removed. Mold growth was also noted on wall-mounted AC units in both the upstairs and downstairs IT rooms (Pictures 15 and 16). However, these units are plastic, which can be cleaned.

**Supply vent, note stained gypsum wallboard above vent, which is likely mold growth from water damage**

12. Remove/replace/refinish any water-damaged ceiling tiles and building materials including scraping loose paint and sealing water-damaged ceiling and wall plaster.

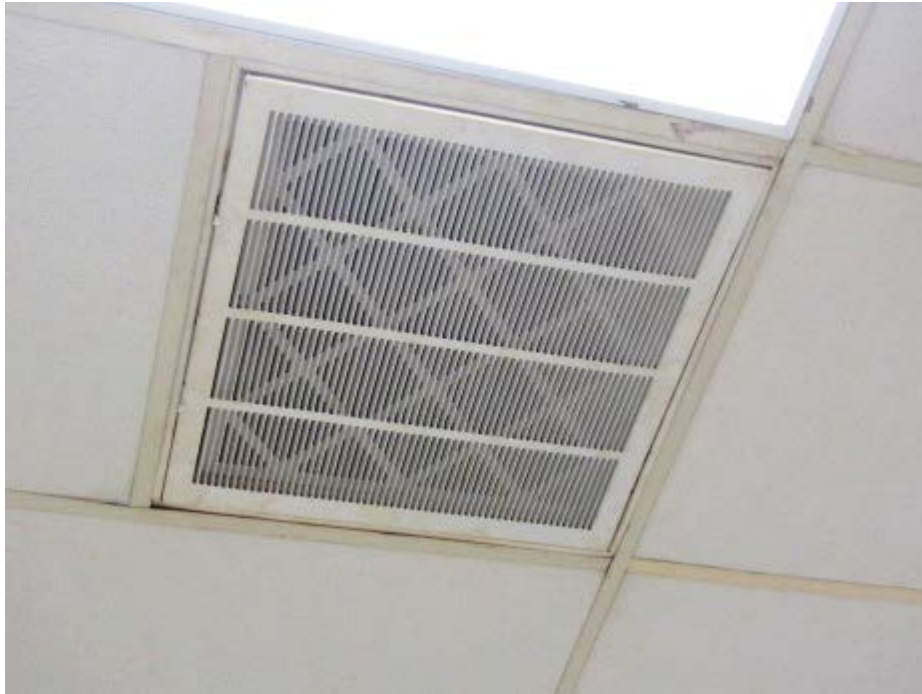
**Picture 3**

**Ceiling-mounted return vent, note filter**

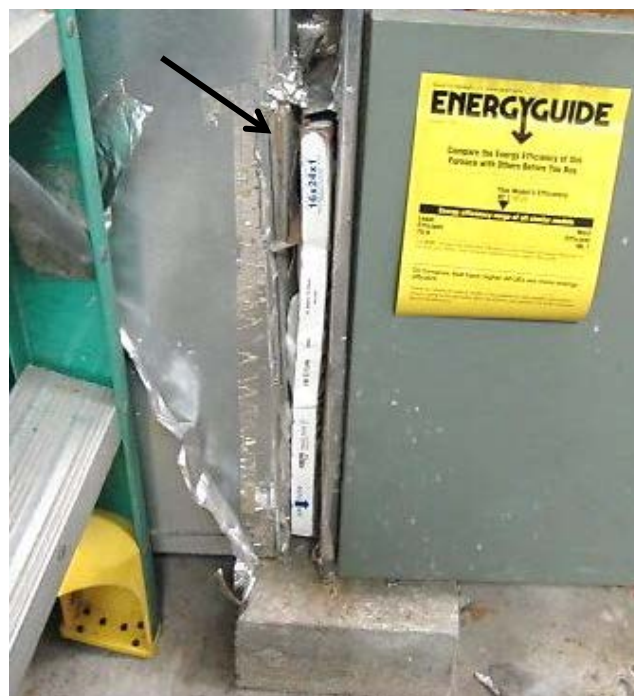
**Picture 4**

It is also important to note that one of the AHUs was missing its filter panel (Picture 4), which can draw airborne dust/debris into the unit (called filter bypass) and distribute into occupied areas. This can serve as a source of respiratory irritation.

**AHU in mechanical room missing filter panel (arrow)**

2. Have the spilled fuel oil/absorbent material in the boiler room removed/properly cleaned.
3. Replace filter panel for AHUs.
4. Ensure filters for AHUs are of a pleated variety, Minimum Efficiency Reporting Value (MERV) dust-spot efficiency 8 or higher, which are adequate in filtering out pollen and mold spores (ASHRAE, 2012). Filters should be changed 2-4 times a year or in accordance with the manufacture's recommendations.

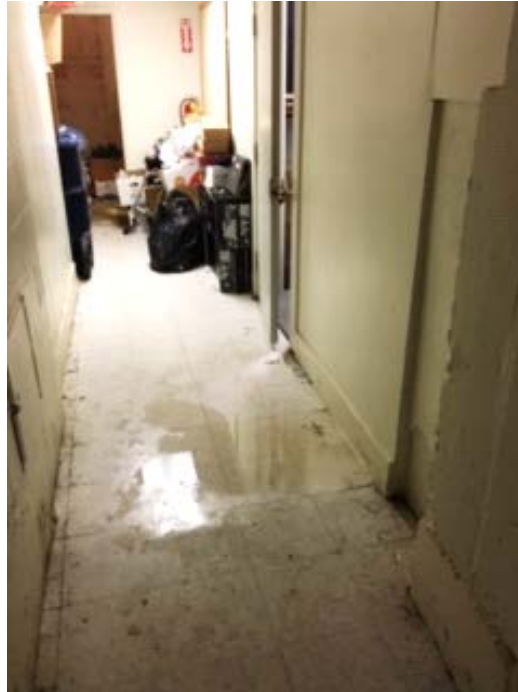
**Picture 5**

The building has chronic issues with water penetration, as demonstrated by stained/damaged materials seen throughout the space, as well as from photographs provided by OBTH staff (Pictures 5 through 14). The US Environmental Protection Agency (US EPA) and the American Conference of Governmental Industrial Hygienists (ACGIH) recommends that porous materials (e.g., wallboard, carpeting) be dried with fans and heating within 24 to 48 hours of becoming wet (US EPA, 2008; ACGIH, 1989). If porous materials are not dried within this time frame, mold growth may occur.

**Water infiltration in lower level**

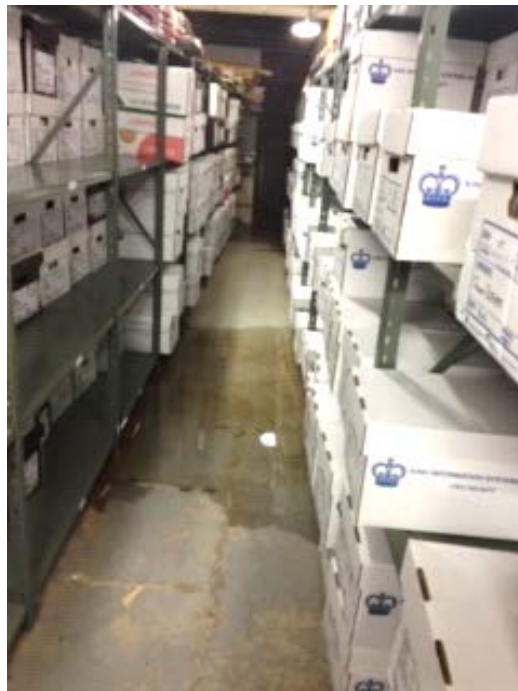
**Picture 6**

An unconditioned space in the lower level is used for records storage. The dampness in this space makes it a poor choice for storing porous materials such as paper and cardboard (Pictures 6 through 8). Elevated humidity and condensation may lead to the moistening/mold contamination of these materials, which would need to be discarded. The severe corrosion of the metal roof in this area demonstrates chronic dampness in this area (Pictures 17 and 18).

**Water infiltration in lower level**

11. Consider installing an HVAC system for climate controlled environment in lower level records storerooms. If chronic water penetration persists, consider removing

all stored porous materials from areas affected and store in a lower humidity environment.

20. Store porous items (i.e., cardboard and paper) off the floor in sealed boxes, bags or totes to prevent water damage. Discard water-damaged and/or moldy materials.

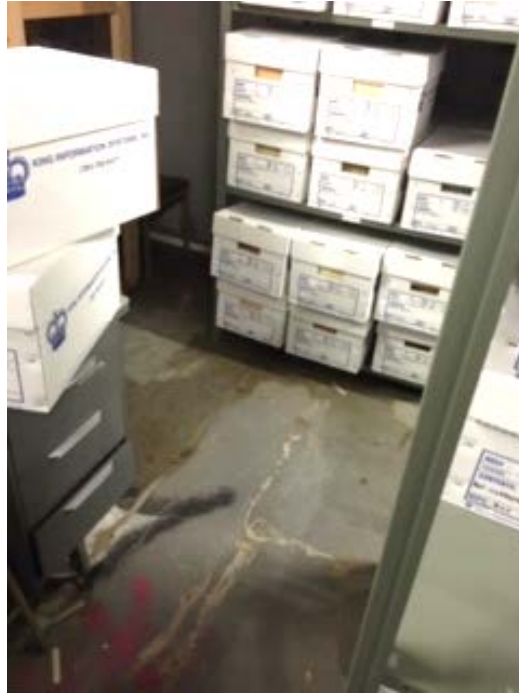
**Picture 7**

**Water infiltration in lower level**

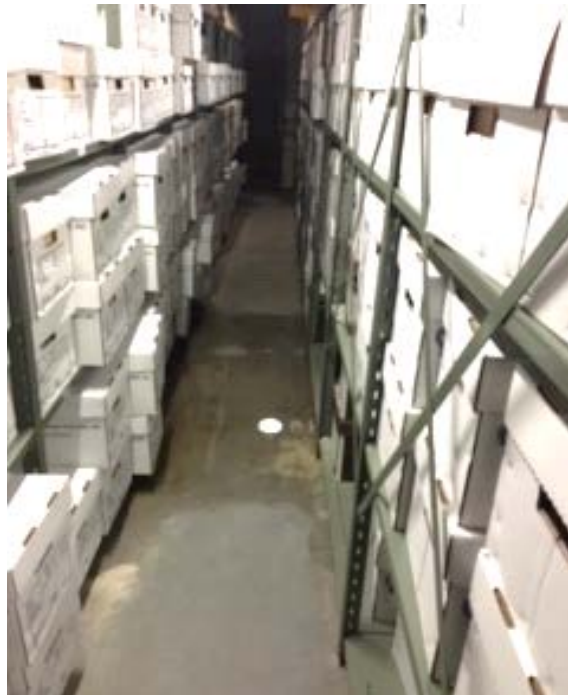
**Picture 8**

**Water infiltration in lower level**

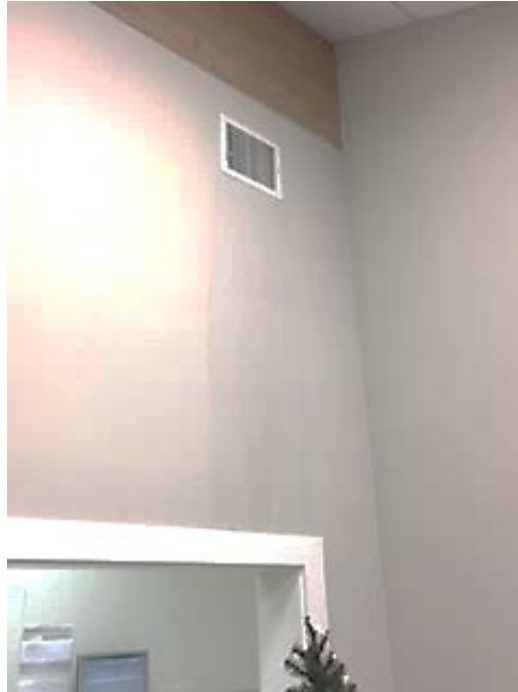
**Picture 9**

**Moisture coming from vent in Building Department**

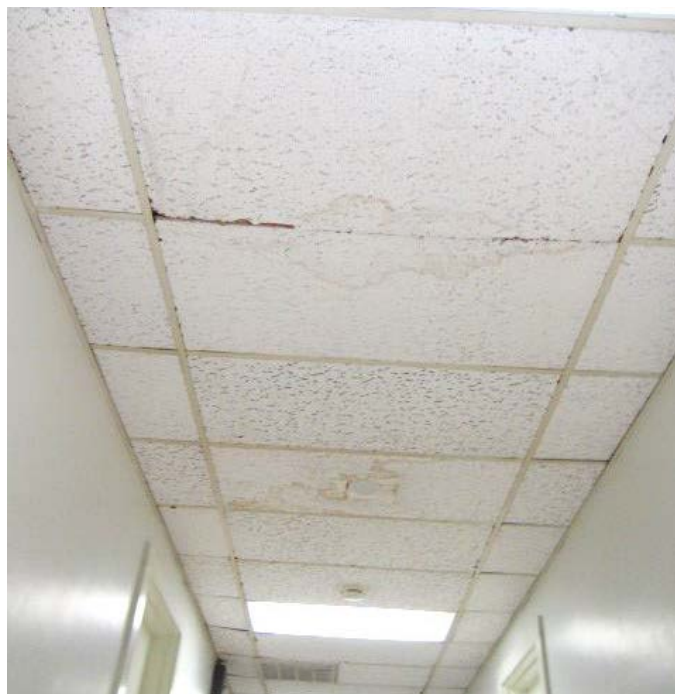
**Picture 10**

**Water-damaged ceiling tiles**

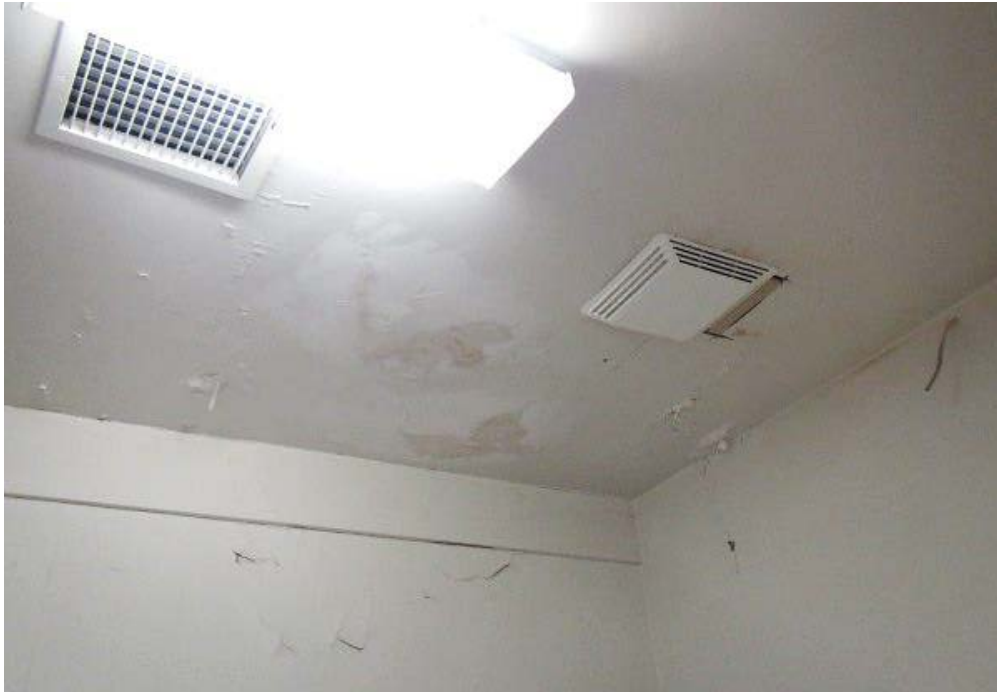
**Picture 11**

**Peeling paint and water-damaged ceiling and walls in men's restroom**

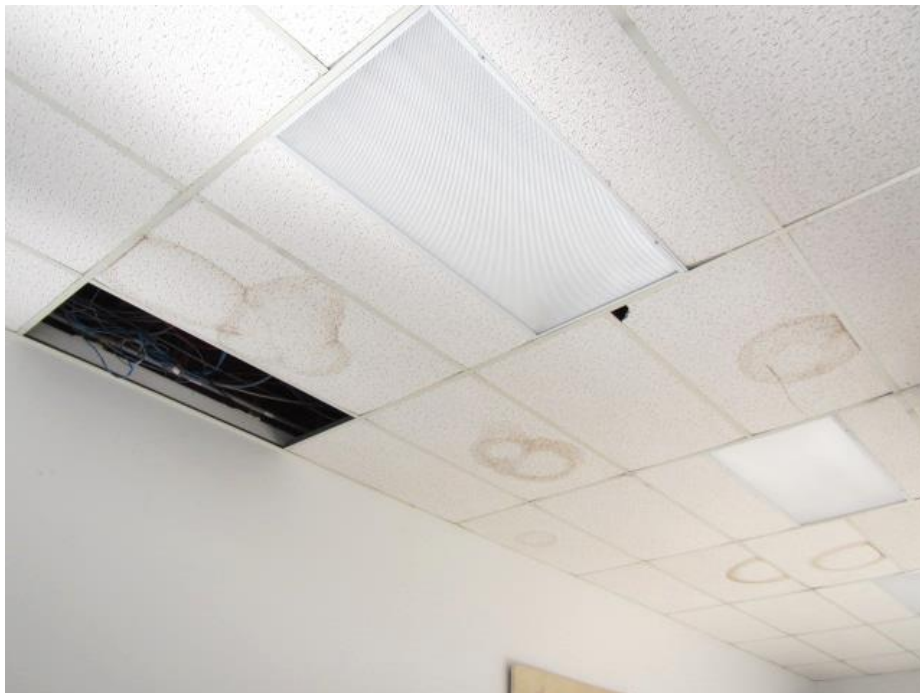
**Picture 12**

Missing/damaged ceiling tiles were observed in a number of areas (Table 1, Pictures 12 and 27), which can provide a pathway for dust/debris above ceiling tiles into occupied areas. Exposed fiberglass was observed in the Conservation Commission, which can provide a source of skin, eye and respiratory irritation.

**Missing/water-damaged ceiling tiles in lower level meeting room**

13. Clean the mold from the air conditioners in the IT rooms. Ensure condensation from these units can drain from the building.
14. Replace missing/damaged ceiling tiles.

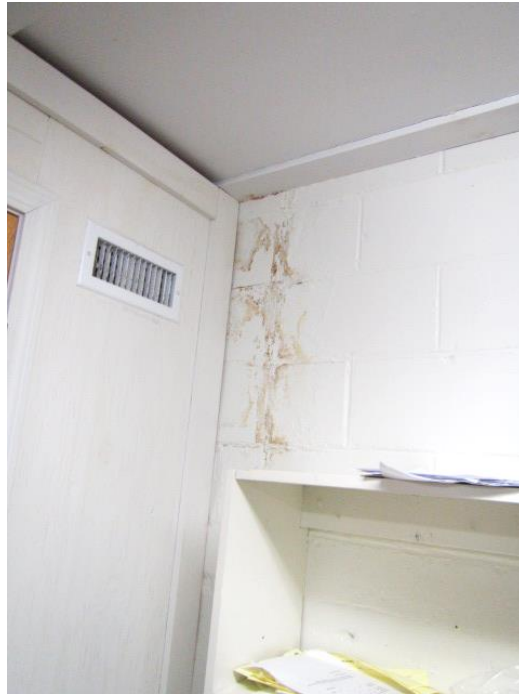
**Picture 13**

**Water-damaged wall lower level**

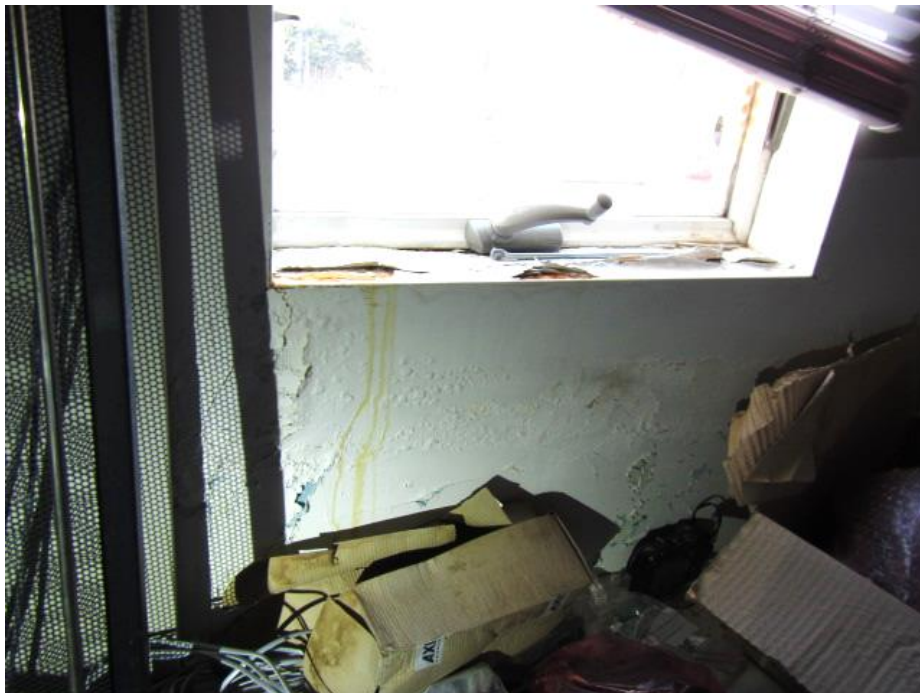
**Picture 14**

**Severe water damage in IT room**

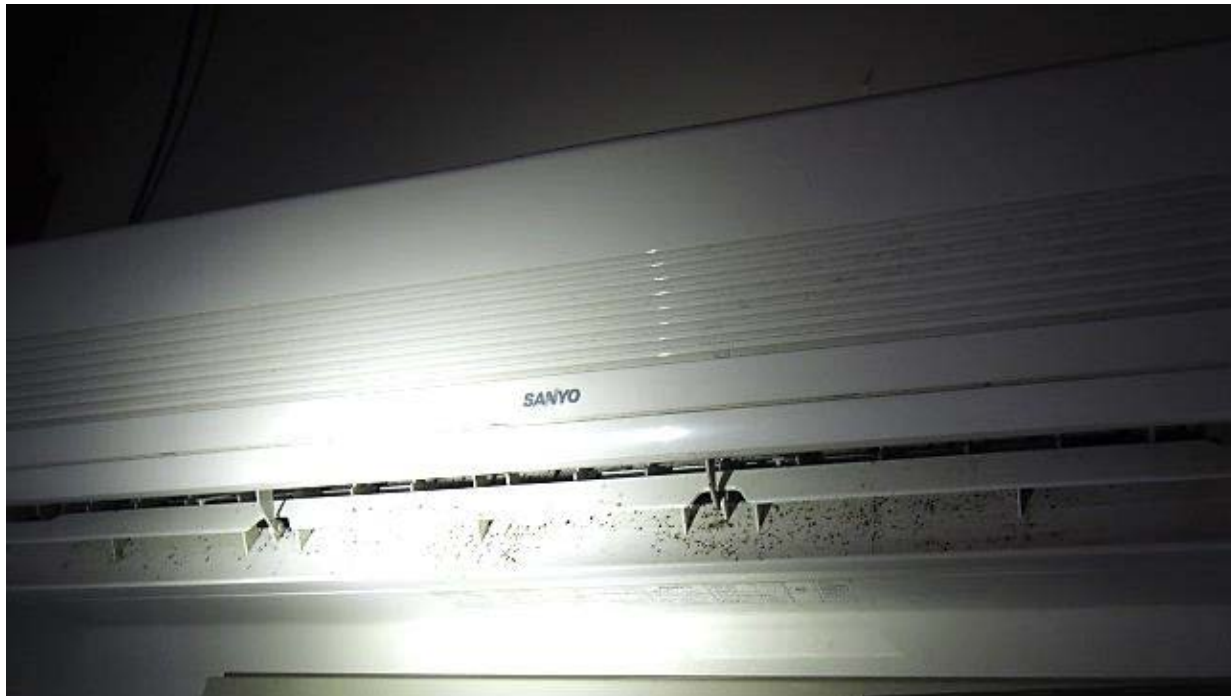
**Picture 15**

**Visible mold growth (dark spots) on AC unit in upstairs IT room**

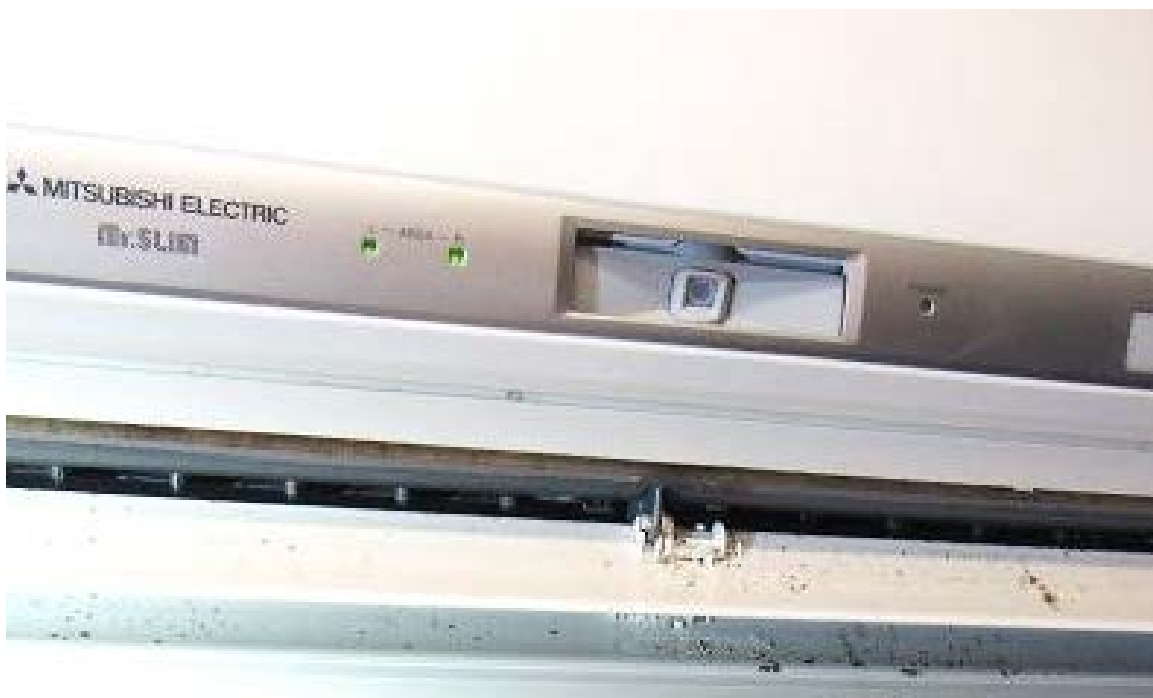
**Picture 16**

**Visible mold growth (dark spots) on AC unit in downstairs IT room**

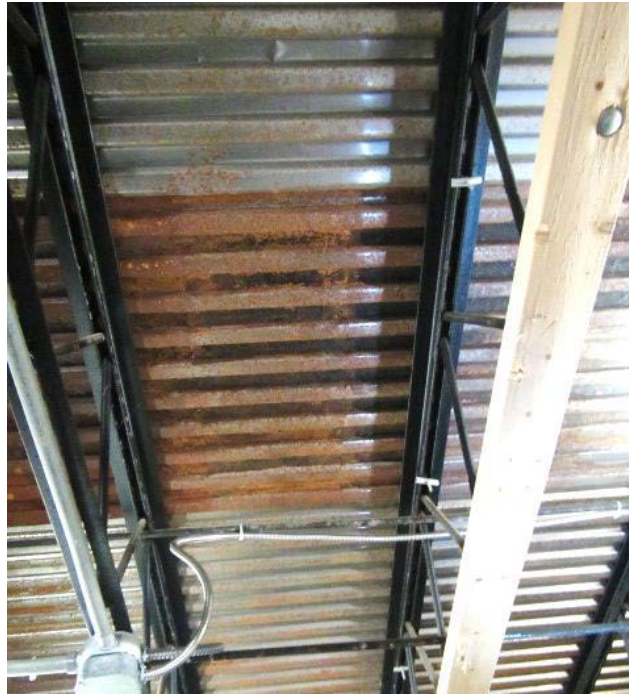
**Picture 17**

**Corrosion of metal roof, lower level**

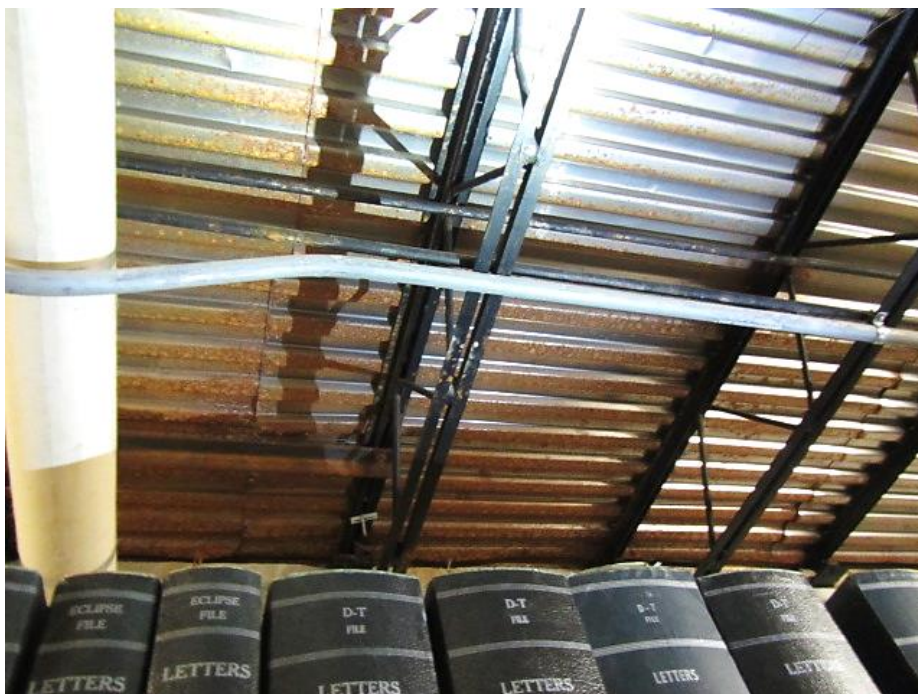
**Picture 18**

**Corrosion of metal roof, lower level**

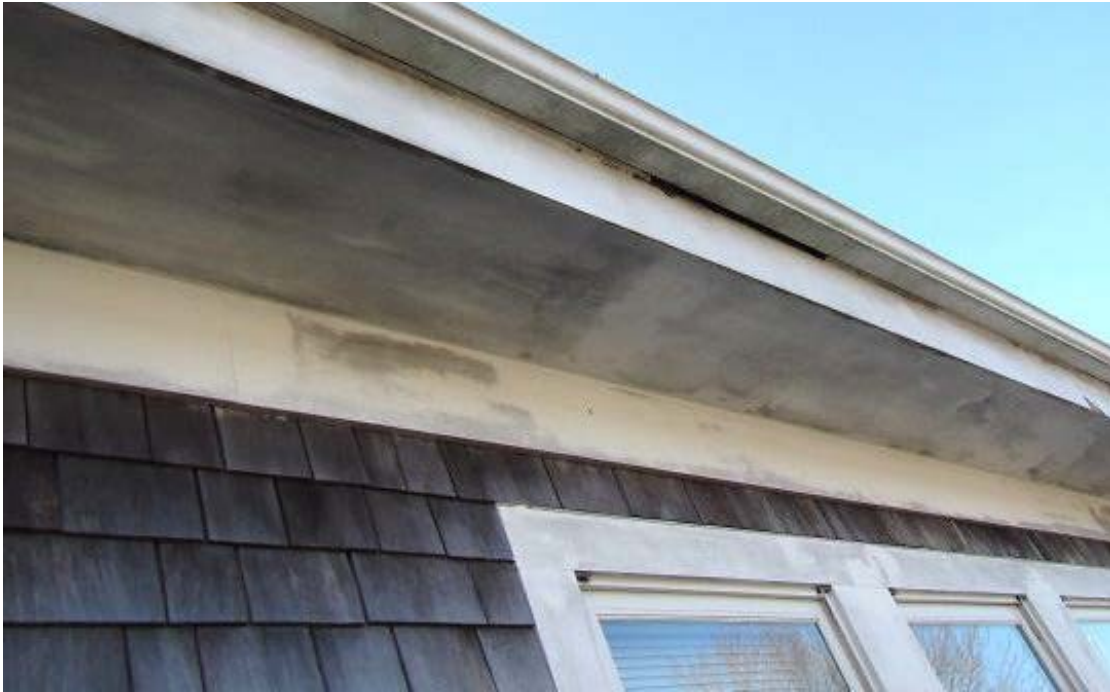
**Picture 19**

- Wooden fascia board was missing/damaged near the roof (Picture 19);
- Missing/damaged wooden shingles (Picture 20);
- Missing/damaged window caulking (Picture 21);
- Clinging plants on exterior walls (Pictures 22 and 23);
- Exterior doors that do not shut (Picture 23); and
- Missing/damaged gutters and downspouts (Pictures 24 and 25).

**Missing/damaged fascia board near roof**

9. Make repairs to inoperable windows or replace.
10. Make repairs to the building envelope (roof, windows, fascia, etc.) to prevent further leaks and damage including:

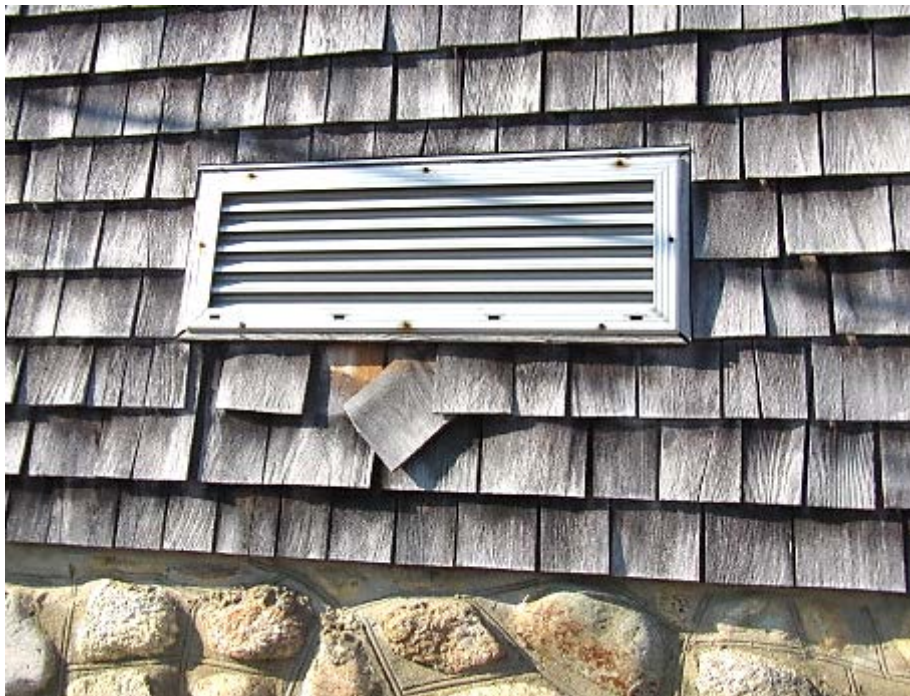
**Picture 20**

**Missing/damaged wooden shingles**

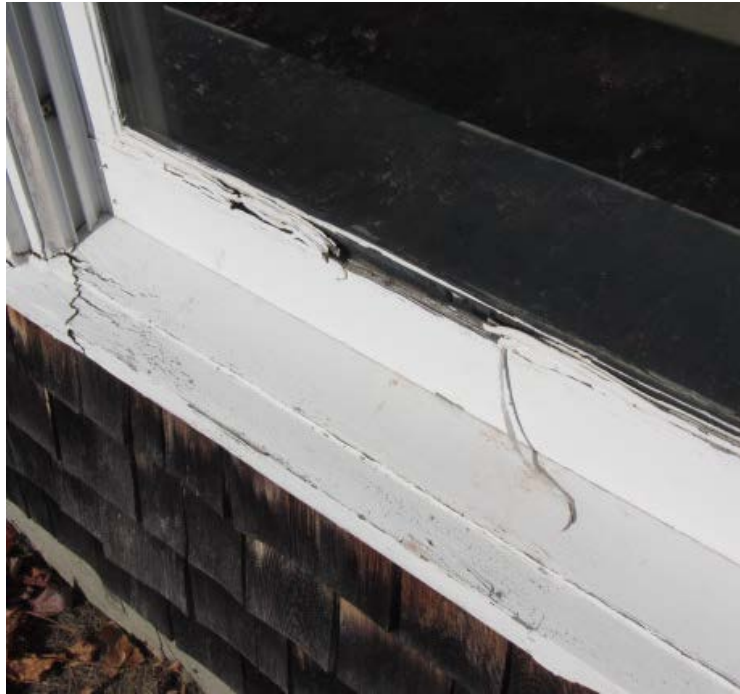
**Picture 21**

**Missing/damaged window caulking**

- a. Replace missing/damaged window caulking.
  - b. Replace missing/damaged gutters/downspouts.
  - c. Remove clinging plants from exterior walls.
  - d. Repair/replace door to boiler room, ensure it closes properly.

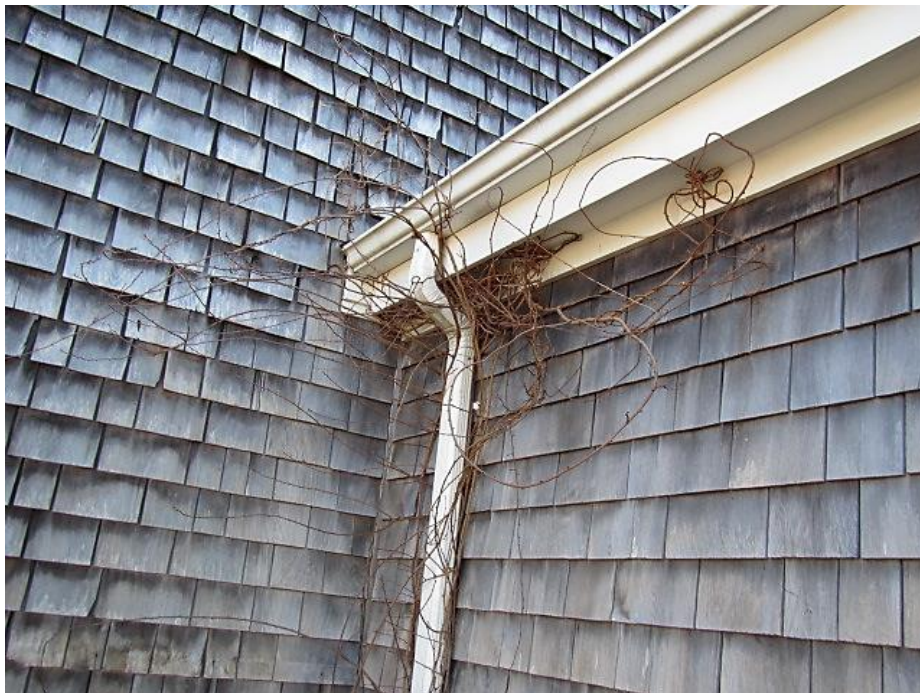
**Picture 22**

**Clinging plants**

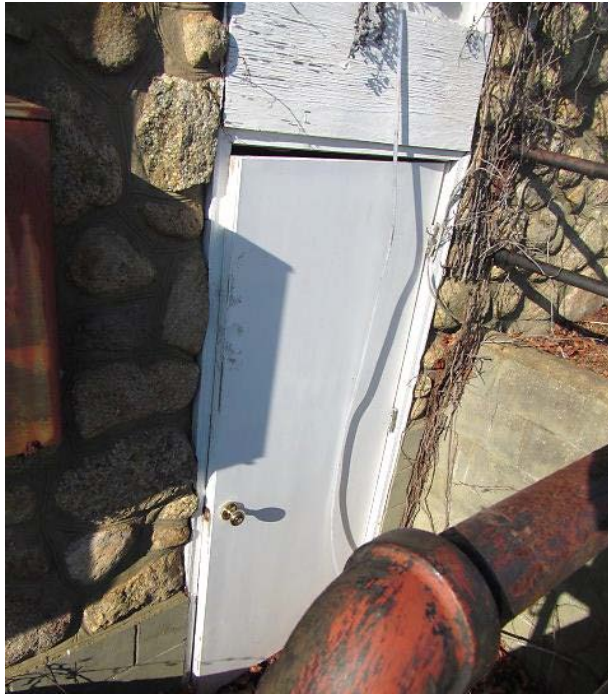
**Picture 23**

An oil spill occurred in the boiler room prior to the BEH/IAQ assessment during refueling (Picture 28). Fuel oil odors were detected in the adjacent areas of the lower level, most likely due to the pressurization of the boiler room due to the exterior door that does not shut properly (Picture 23), which may allow uncontrolled introduction of outside air into the building. Pressurization would force odors (and any other airborne dust/debris) through open utility holes that might exist in the common wall/ceiling of the boiler room.

**Door to boiler room that does not shut, also note clinging plants**

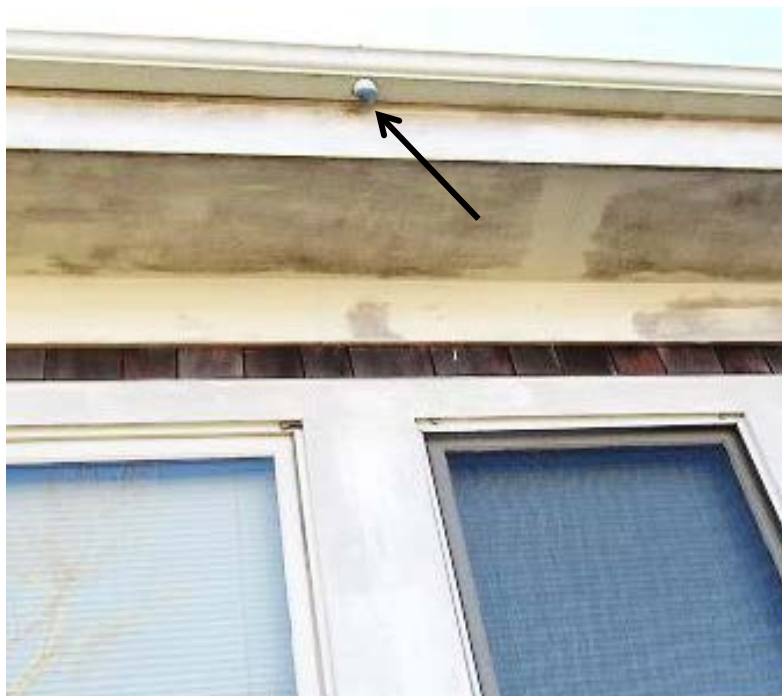
**Picture 24**

**Missing downspout (arrow)**

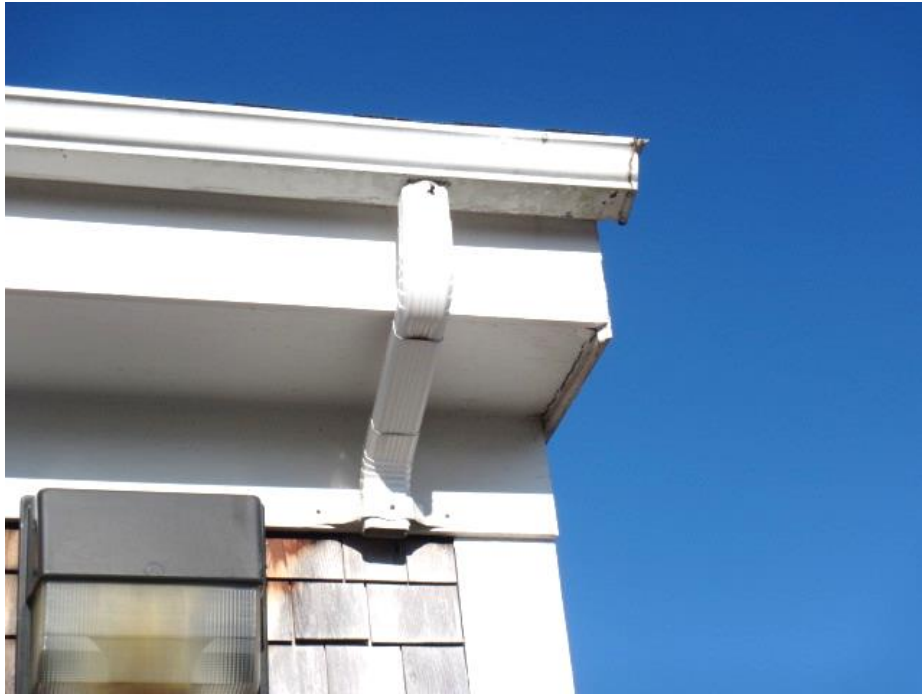
**Picture 25**

**Missing downspout**

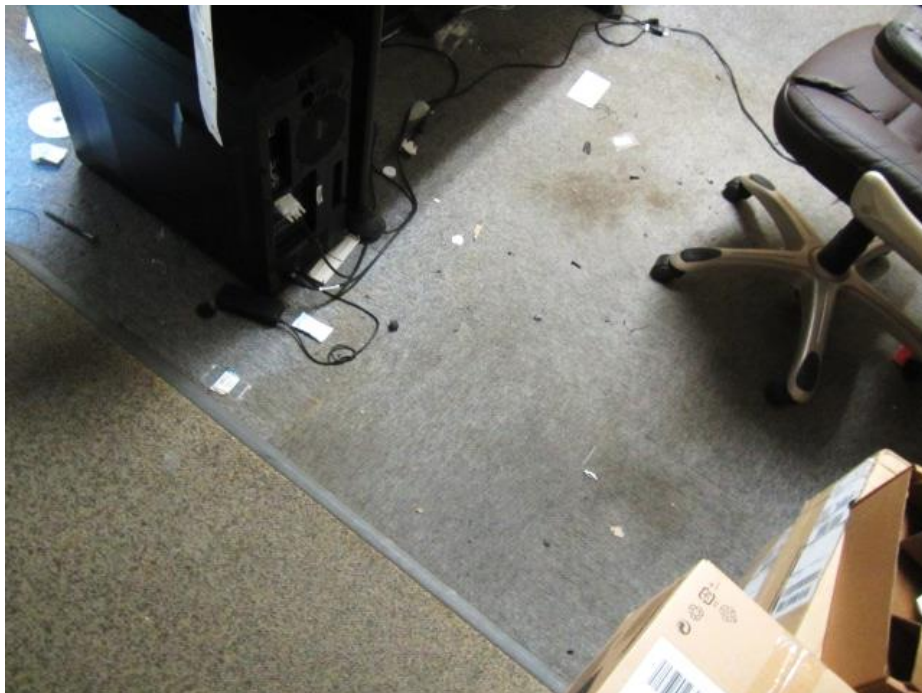
**Picture 26**

Several areas were carpeted. Carpets should be cleaned annually (or semi-annually in soiled/high traffic areas) in accordance with Institute of Inspection, Cleaning and Restoration Certification (IICRC) recommendations, (IICRC, 2012). The service life of carpeting is approximately 10-11 years (IICRC, 2002). In some areas, carpeting was observed to be worn and stained (Picture 26). Carpeting of this age and condition becomes increasingly difficult to clean and maintain and may be a source of particulate matter to the indoor environment. Regular cleaning with a high efficiency particulate air (HEPA) filtered vacuum in combination with an annual cleaning will help to reduce accumulation and potential aerosolization of materials from carpeting.

**Stained/worn carpeting**

21. Regularly HEPA vacuum remaining carpeting/area rugs and clean carpeting at least once per year according to IICRC recommendations (IICRC 2012). Consider replacing any carpeting that is beyond its service life. In below-grade areas, consider using non-porous flooring instead of carpeting when flooring is replaced.

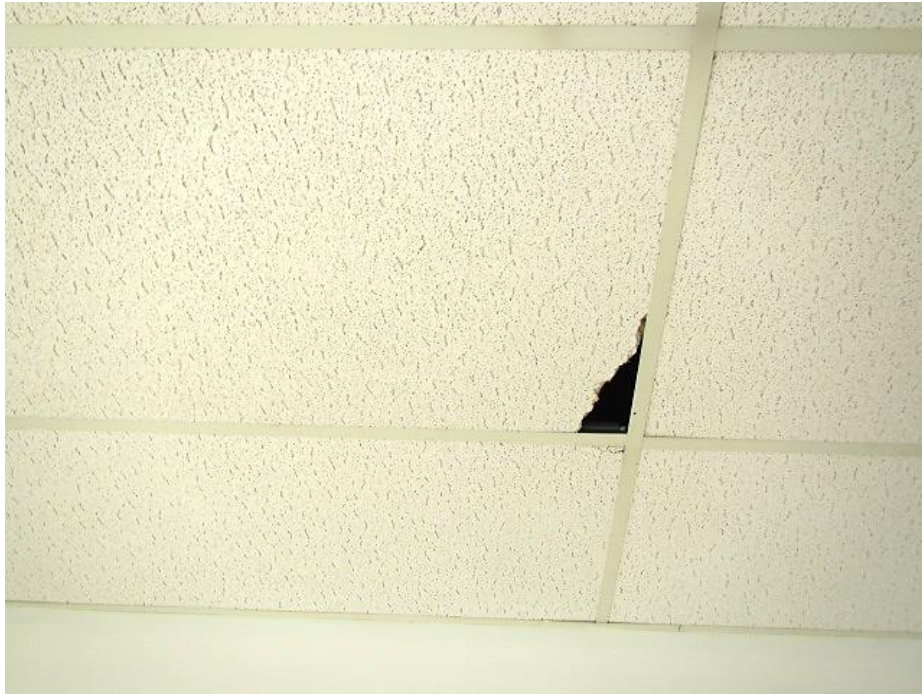
**Picture 27**

**Damaged ceiling tile**

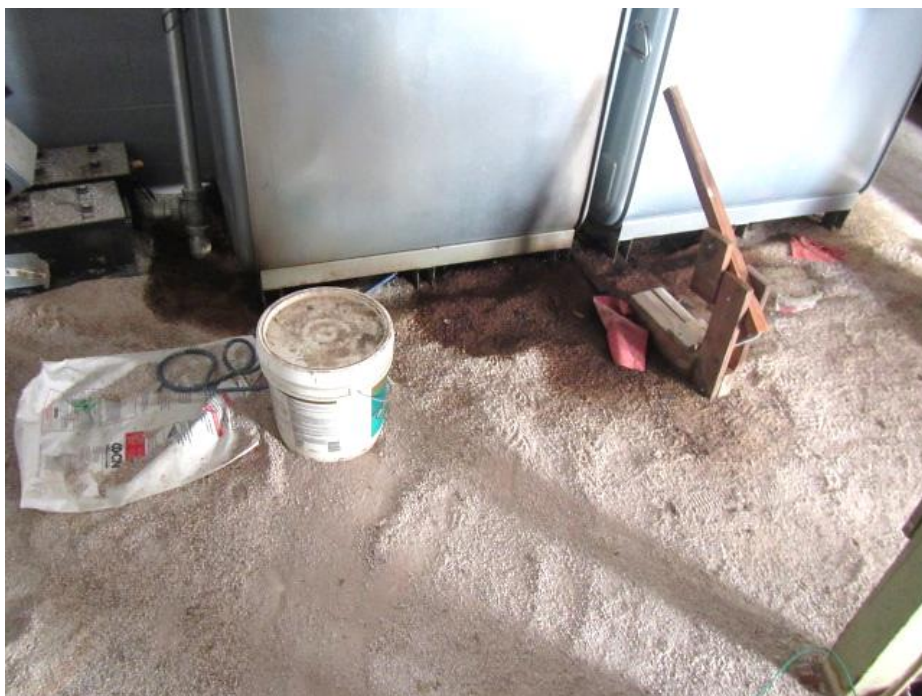
**Picture 28**

**Fuel oil spill and absorbent material in boiler room**

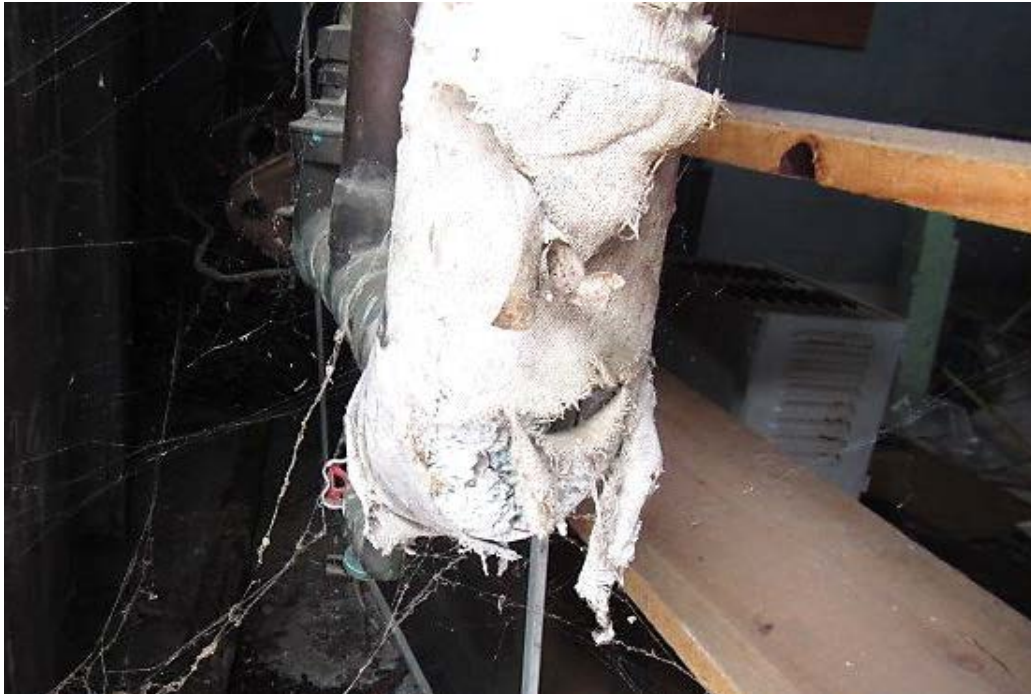
**Picture 29**

Finally, damaged pipe insulation (Pictures 29 and 30) was noted in the boiler room and lower level hallway and damaged floor tiles were observed in the early voting room (Picture 31). Due to the age of the building these tiles may be asbestos containing materials (ACM). Intact ACM does not pose a health hazard. If damaged, ACM can be rendered friable and become aerosolized. Friable asbestos is a chronic (long-term) health hazard, but will not produce acute (short-term) health effects (e.g., headaches) typically associated with buildings believed to have IAQ problems. Where asbestos-containing materials are found damaged, these materials should be removed or remediated in a manner consistent with Massachusetts asbestos remediation laws (MDLI, 1993). It was reported by Health Agent, Meegan Lancaster, that the Massachusetts Division of Labor and Industries (MDLI), Asbestos Program was contacted for assistance on this matter.

**Damaged pipe insulation in boiler room**

1. Continue with plans to have damaged insulation and floor tiles addressed by MDLI/remediated in accordance with state and federal regulations for asbestos-containing materials.

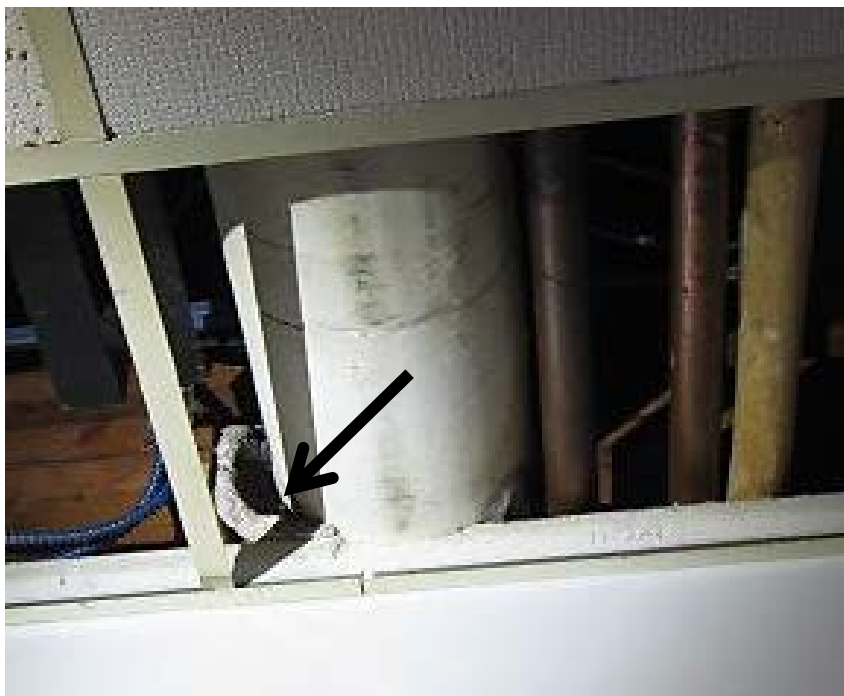
**Picture 30**

**Loose/damaged pipe insulation (arrow) in lower level hallway above ceiling**

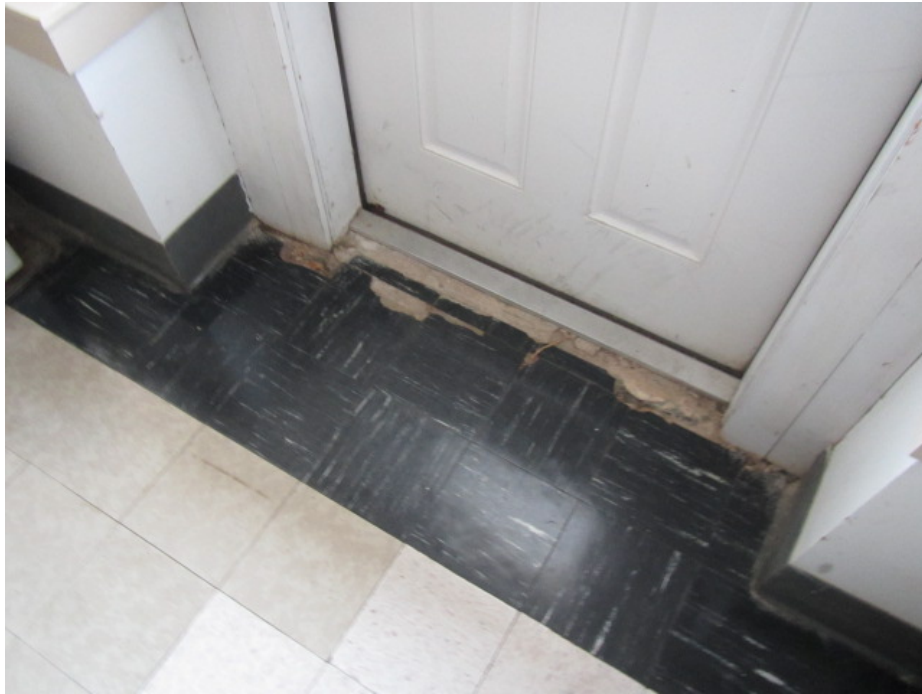
**Picture 31**

**Damaged floor tiles in Early Voting room**

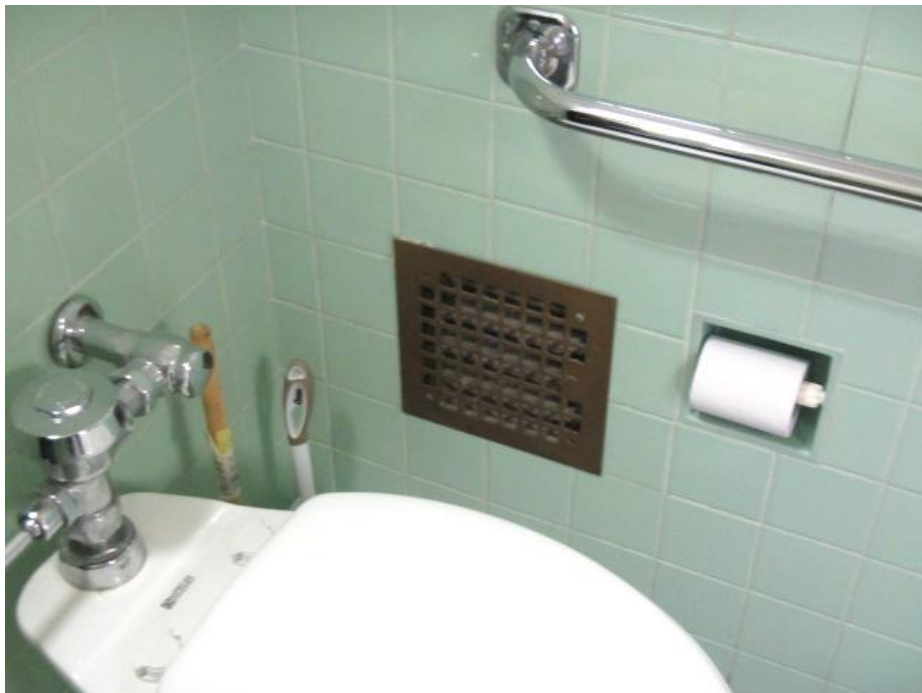
**Picture 32**

**Abandoned exhaust vent in restroom that was backdrafting cold air**

17. Seal abandoned exhaust vents in restrooms that are backdrafting (Picture 32).
18. Seal open utility holes/breaches in ceilings, floors and walls with a fire-rated sealant, particularly in the boiler room.
